AUSMAP Microplastic Summary Report

Georges River Catchment

Sampling Period: November 2024 – February 2025

Prepared for
Georges Riverkeeper, NSW

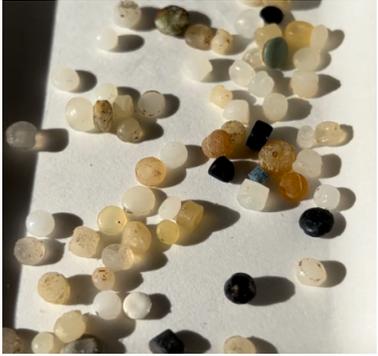
Microplastic Type	Example Image Identification	Microplastic Type	Example Image Identification
Pellets/ Nurdle

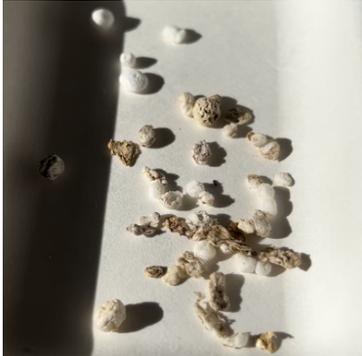
Foam

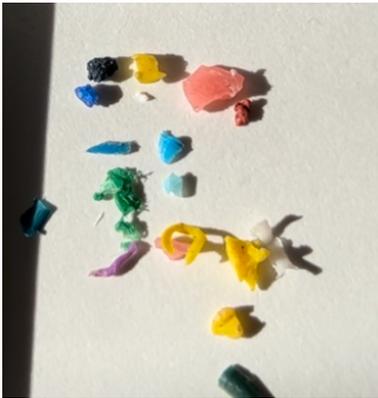
Hard Fragment

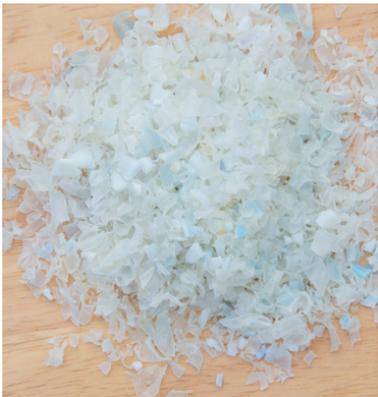
Soft Film

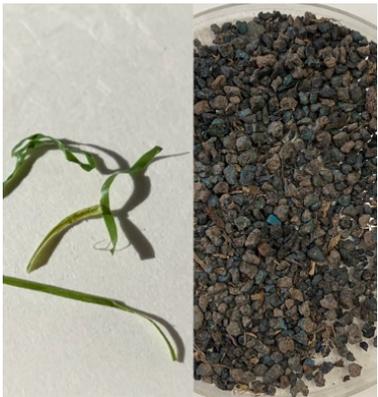
Artificial Grass/ Rubber Crumb

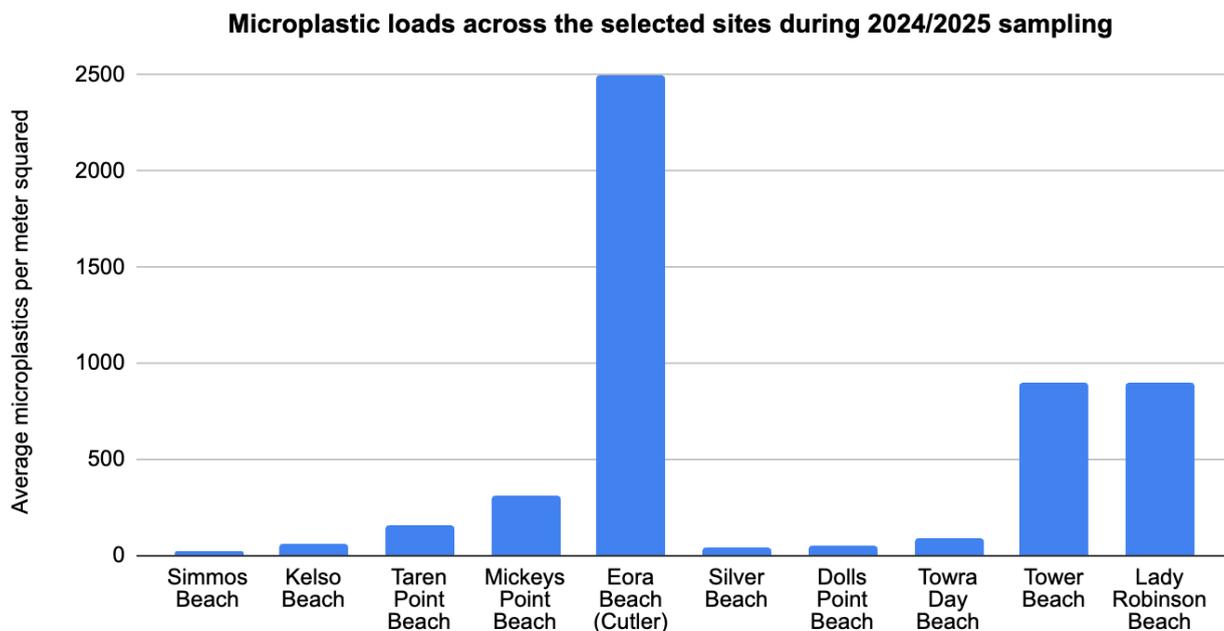
Figure 1. Average microplastic loads across the selected sites during the 2024/2025 monitoring

Microplastic pollution was found at all surveyed sites (Fig. 1) but varied widely between locations, reflecting a complex pattern of pollution pressures within the Georges River and Botany Bay catchment.

- The highest microplastic pollution level was recorded at **Eora Beach** (formerly named Cutler Beach due to the closest street), with an average of **2,495 microplastics per square metre** and categorised as **Very High** according to the AUSMAP pollution scale. This concentration indicates a significant local source or accumulation hotspot, warranting further investigation and targeted management action.

- **High** microplastic levels were also observed at several other sites, suggesting persistent or upstream pollution inputs: **Lady Robinson Beach** (899 MP/m²); **Tower Beach** (896 MP/m²); and **Mickeys Point Beach** (313 MP/m²).

- **Moderate** microplastic levels were detected at: **Taren Point Beach** (161 MP/m²); **Kelso Beach** (59 MP/m²); **Towra Day Beach** (91 MP/m²); and **Dolls Point Beach** (53 MP/m²).

- **Low** microplastic levels were found at **Silver Beach** (42 MP/m²) and **Simmos Beach** (22 MP/m²).

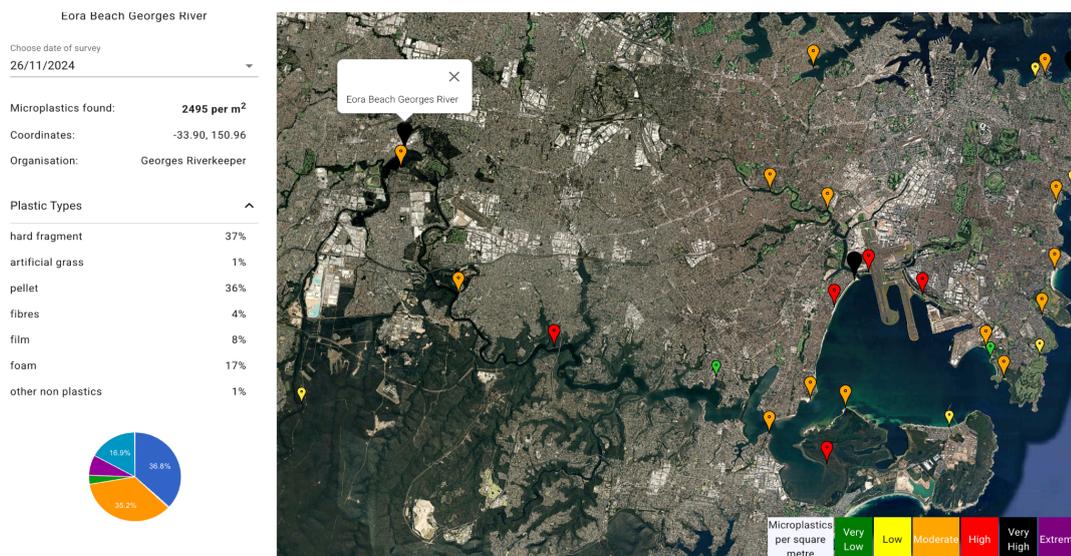
Figure 2: AUSMAP National Microplastic Hotspot Map showing data Georges Riverkeeper dataset

Analysis of colour data revealed that opaque particles were the most dominant across most sites, particularly at high-load locations such as Lady Robinson and Eora Beaches, aligning with the prevalence of similarly coloured pellets. Several other sites, including Simmos Beach, Taren Point Beach, Silver Beach, and Tower Beach, contained notable proportions of green particles, primarily consisting of irregular hard fragment shavings. Further details on microplastic colour, size and shape are provided in an accompanying summary spreadsheet and can be seen on the AUSMAP Hotspot Map (See Figure 2 as an example).
